25 Bessemer Park Industrial Estate

Schedule of Condition of Premises

taken for the London Ambulance  
Service NHS Trust

on the 03 November 2006

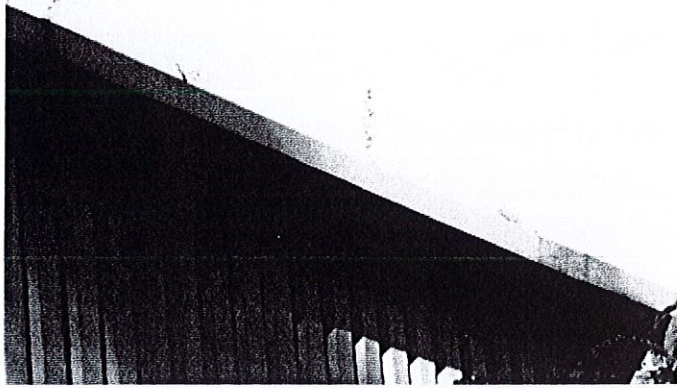
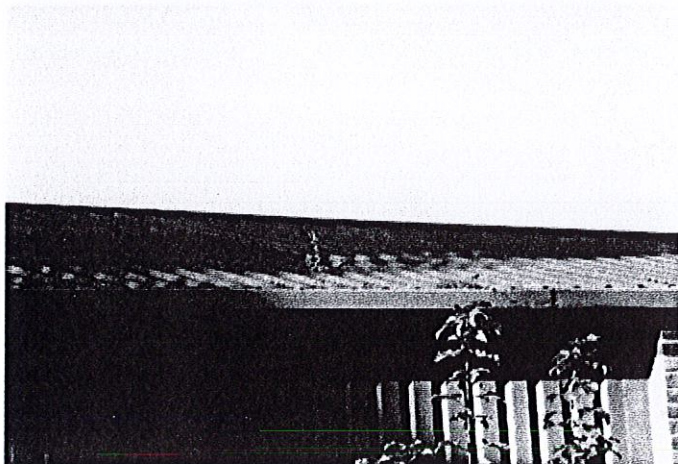
- 17.00 The gutters are evidently badly silted up as there is evidence of plant growth with in them (photos 5 and 6). It is recommended that these are cleared and inspected during the course of the refurbishment.

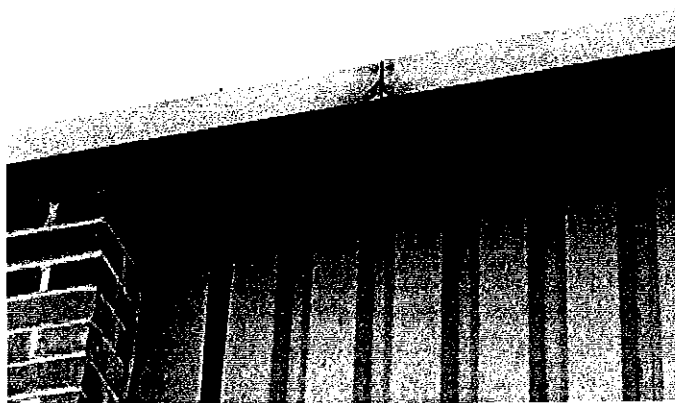
- 16.00 The guttering and down pipes (photos 5 to 11 inclusive) are fair to poor in condition. Junction seams (photos 9 and 10) in main runs and at corners are evidently poor with visible seepage and discolouration. The colour coating of these elements has also deteriorated quite badly under ultra-violet light. There has been some severe seepage and discolouration on the down pipe in the south west corner of the building.

- 18.00 It is likely that the gutters and down pipes will require replacement during the term of the lease.

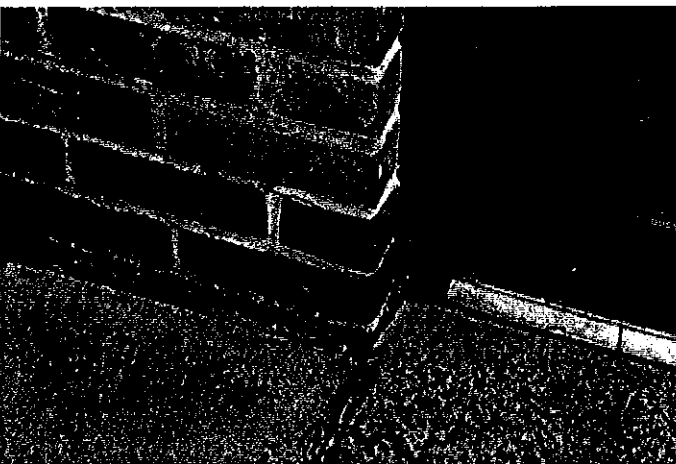
**14**

- 23.00 A DPC is evident as illustrated by photo 14. There is no suggestion to show any deterioration of this element.
- 24.00 There is some minor damage to brickwork adjacent to the fire escape door where the face brickwork has been burst where a cable hole has been made (17).

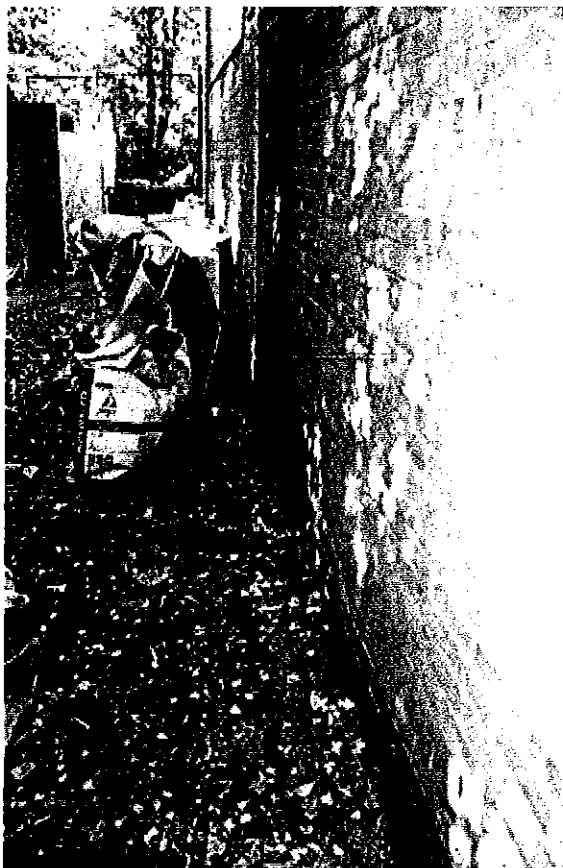
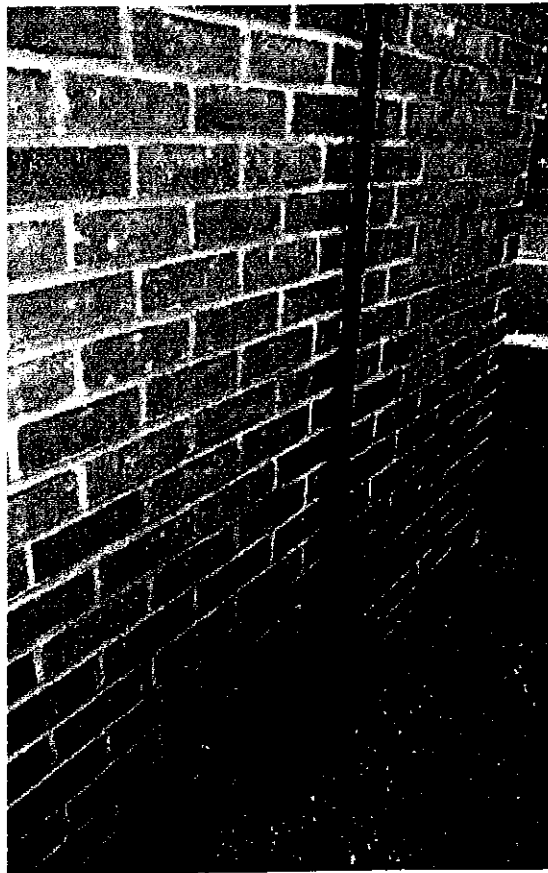
- 21.00 There has been considerable discolouration of the brick panels on the north and south flanks with green algal pigment resulting from poor water throw off from the drips on the cladding panels over. See photos 15, 16 and 18.

- 26.00 It is anticipated that cleaning and the minor repairs of the brickwork could be carried out during the prospective refurbishment works.

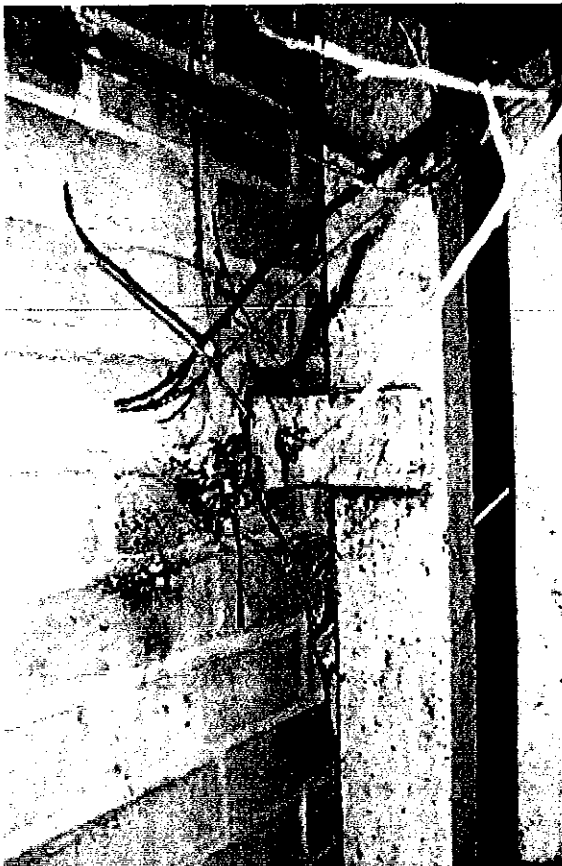
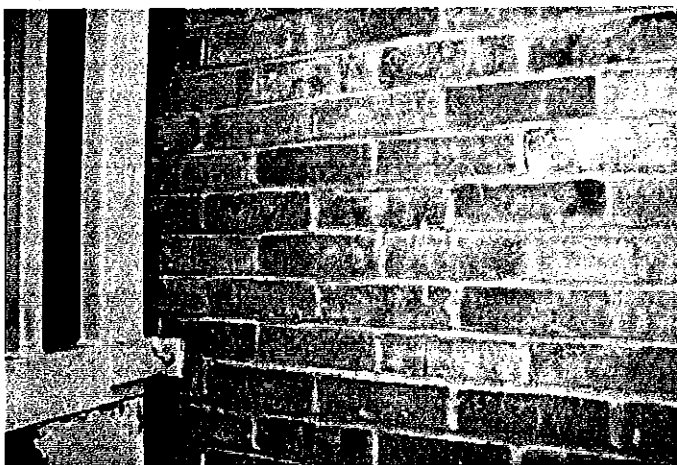
- 25.00 Where the boundary fence has been affixed with bolts to the north and south flanks undue stress has been placed on the masonry and the mortar joints have cracked locally. See photos 19, 20, 21 and 22.

*Defects in brick where  
boundary fence is  
affixed*

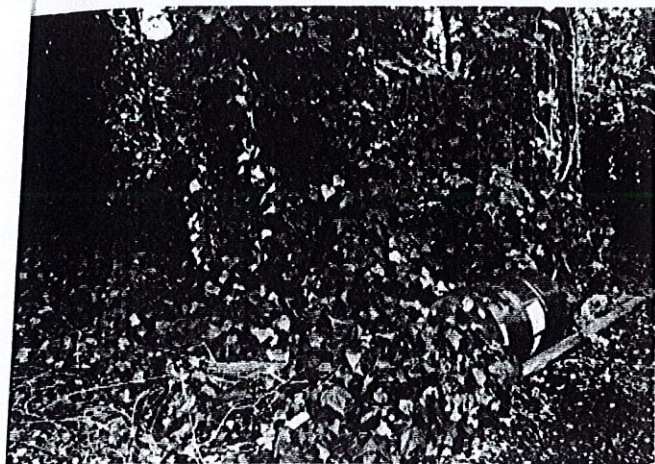
26

- 41.00 At one point in this yard the galvanised fence has been totally removed close to the refuse enclosure (see photo 26). It is likely that a whole section of fence is replaced during the proposed refurbishment.

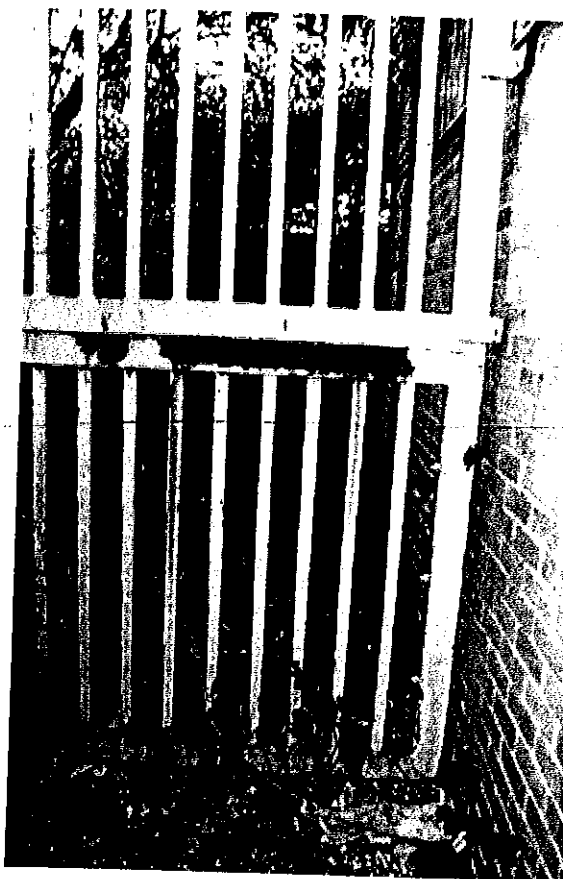
36

- 34.00 The boundary adjacent to the flank to north has cultivated beds with evergreen shrubs and standard trees and it appears that this is well maintained by the estate managers and contractors (see photo 4). The decorative condition of the estate fence which runs up to this flank (photo 36) is poor and this should be redecorated. This may be the responsibility of the estate managers and contractors and should be checked.

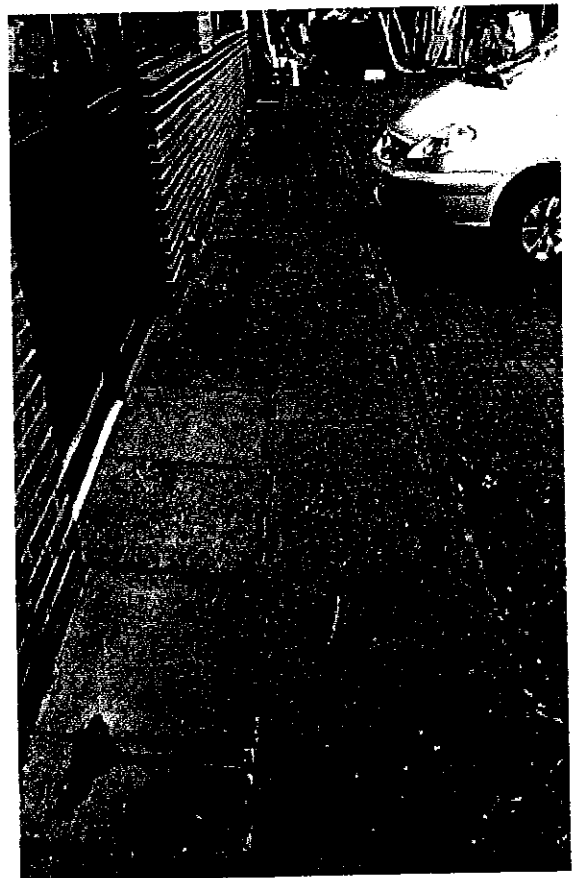
- 45.00 A concrete flagged footway which drops down from the public footway runs in to a similar footway which flanks the main entrance façade. Some of the joints in the flags are disjointed and will require re-setting during the course of the proposed refurbishment. See photos 42 and 43.

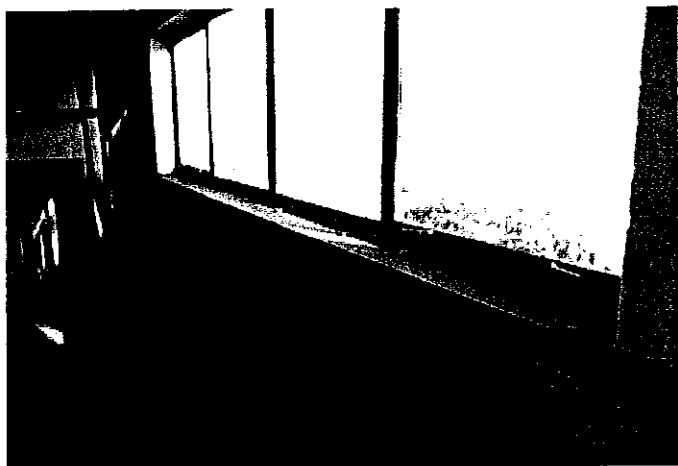
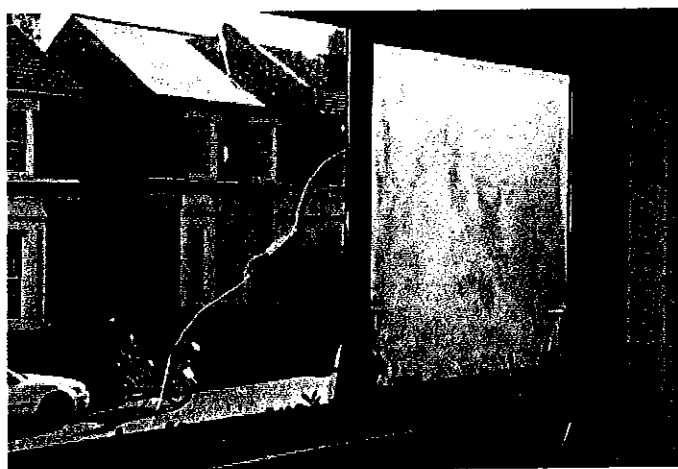
- 29.00 The operation of the individual sashes of the window units and the integrity of their glazing units has not been tested or noted. However, a number of double glazed units have deteriorated and failed and will require replacement during the refurbishment. Individual units shown in photos 58 and 59 (first floor east flank) and within the main entrance screen, photo 63, show typical such deterioration.

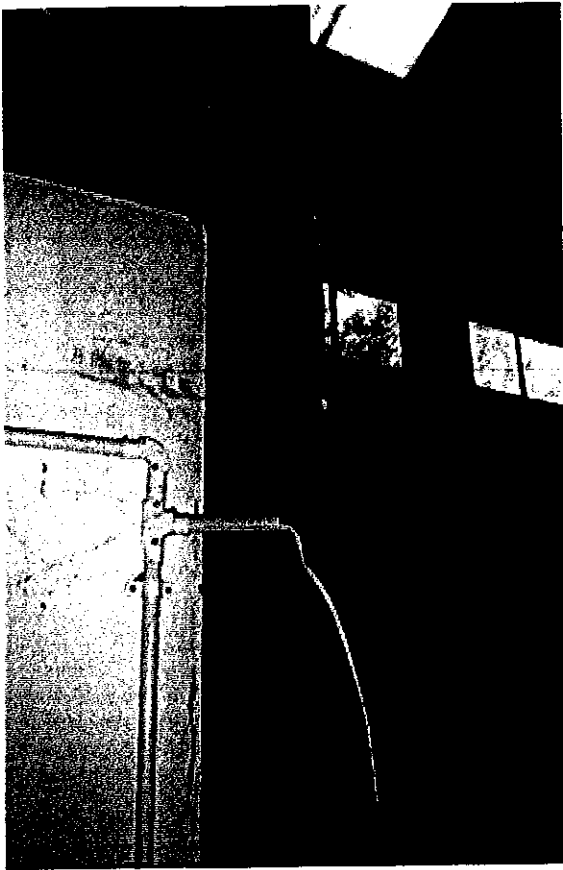
- 61.00        The exposed main frame appears to have been painted with a maroon intumescent paint. Generally this is in good order, but the intumescent paint finish has been chipped on arrises of structural steel members (Photos 67 through 69). These areas should be repaired during the course of the proposed refurbishment.

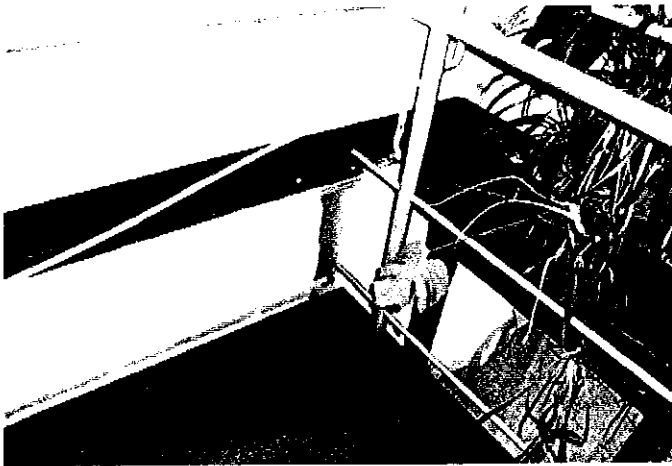
- 62.00        The steel staircase are secondary to the main steel frame but are inter connected (Photos 71 and 72). Where concrete block partition walls have been constructed up to these staircases, cracks are apparent in some blockwork joints and in the blocks themselves. It is likely that this is due to differential movement between the floor, partitions and steelwork.
