25 Bessemer Park Industrial Estate

Schedule of Condition of Premises

taken for the London Ambulance  
Service NHS Trust

on the 03 November 2006

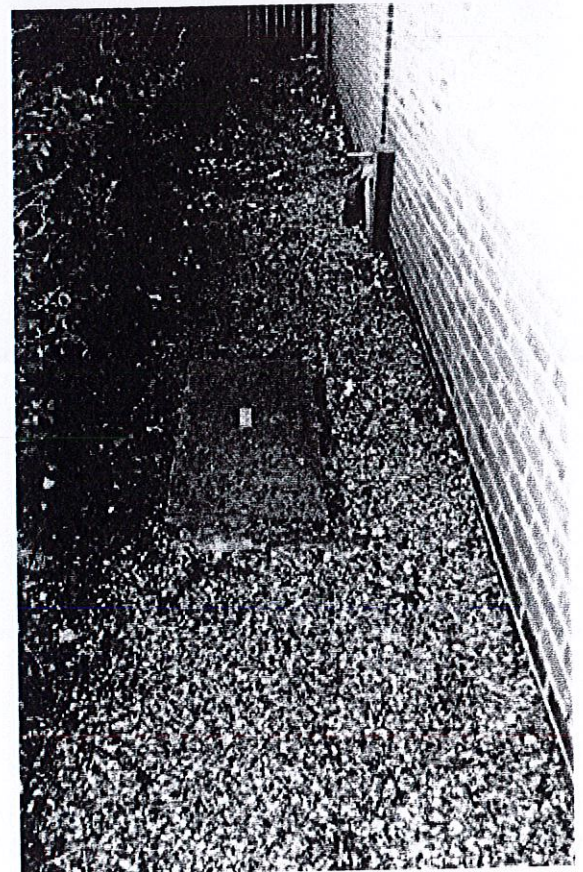
48

- 40.00 A cluster of services (photos 44, 45, and 47) on the north flank is comprised of an insulated polypropylene water main, approximately 28 mm diameter. This is shrouded by a plywood box which should be replaced. A fibre optic or similar cable enters the building close to the water service. It is reasonable to assume this service issues from the concrete covered telecom chamber which may be administered by BT. See photo 48.

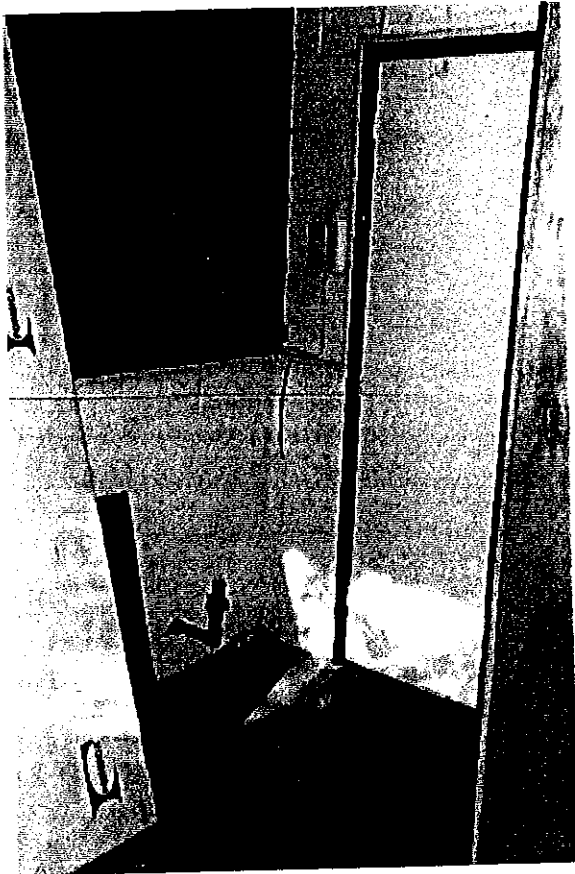
51

- 44.00 This gas main enters the existing warehouse (photo 51) and is capped off as there are no gas burning devices in the building.
- 45.00 The electricity supply enters the building in a swept duct and the main distribution board, consumer unit and meters are located on the wall behind the half landing of the main staircase, within the existing warehouse.
